Restore 'N More, Inc. P.O. Box 128, Manheim, PA 17545 717-664-7575

# This Old House

When last we left off with Tim & Cindy's story (*"From Lehigh to Lancaster," Winter 2010-11 Issue*), their yet-to-be house was safely stored inside their new barn. It still sounds odd....a house in storage. But that's exactly where their house was — in the barn! All the timbers, flooring, siding, trims, etc., etc.

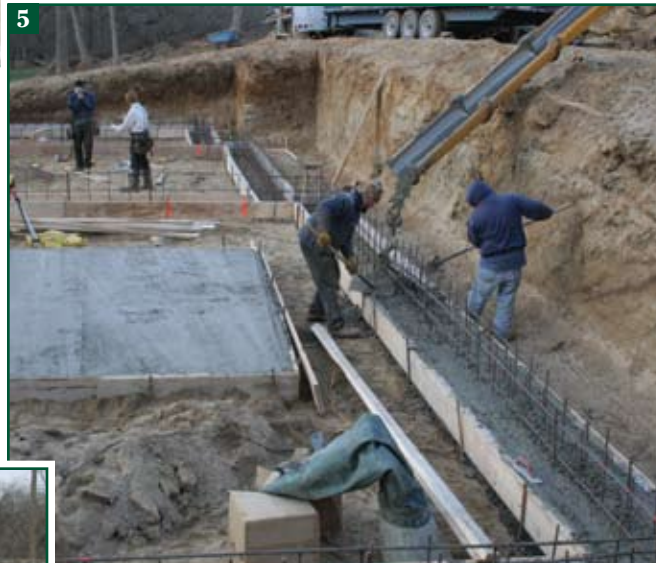
The excavators then moved in and carved out a huge hole. (Photo #4) ‘Til all the digging was completed, the back of the house’s foundation sits squarely on sandstone bedrock. This area near the Conestoga is made up of very sandy soil, but it’s highly compacted. The masons had to literally drill the soil just to get rebar inserted to form the footers. As you can see in the photo (#5), the footers had several offsets making this a little more complicated than usual. And, they had to form and pour a huge 12’ x 12’ x 2’ thick footer and pad to serve as the base for all the central fireplaces. (left of photo)

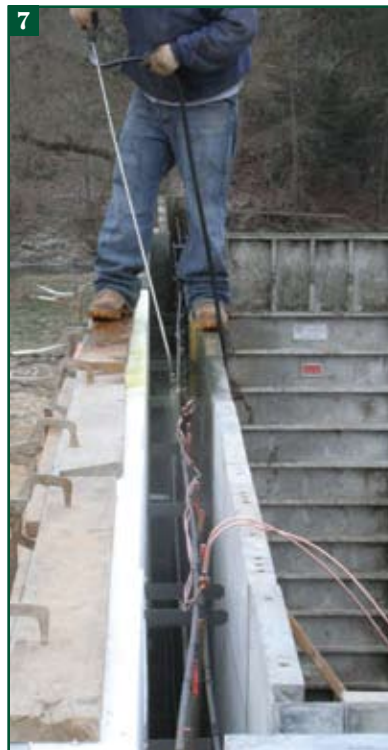
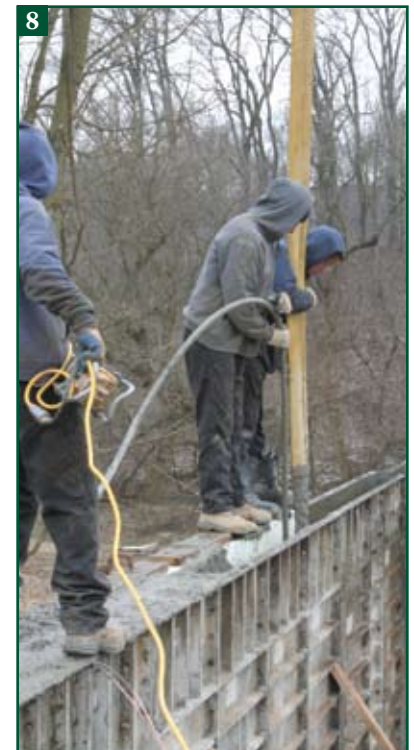
Once the footers were poured and set, the foundation crews erected aluminum forms for the poured concrete walls. (Photo #6) Although the forms go up very quickly, there’s a lot a preparation that goes into them beforehand. Every opening or hole for foundation level (basement) windows and doors, as well as plumbing and electrical portals,

must be incorporated into the forms prior to pouring the concrete. Then, just prior to pouring the concrete, the interior of the forms are sprayed with a petroleum product that prevents the concrete from sticking to the forms. (Photo #7)

The concrete is then pumped into the forms (Photo #8); one man feeds the concrete through an overhead chute, another vibrates the mixture with a long bar, assuring there are no air pockets in the wall. The forms are then stripped off several days later. Because of the cold weather, the forms were blanketed to trap the heat in until the concrete could harden slowly.

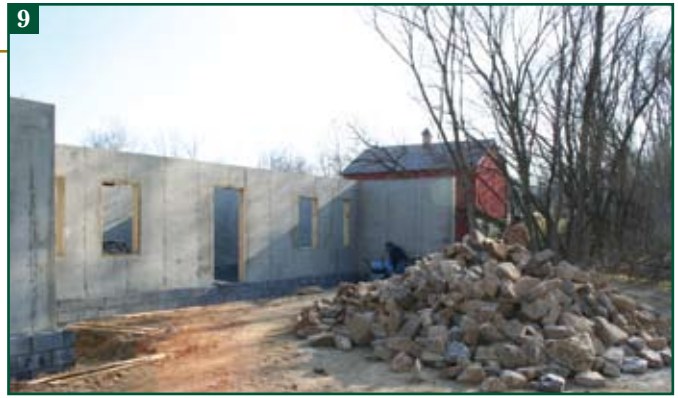
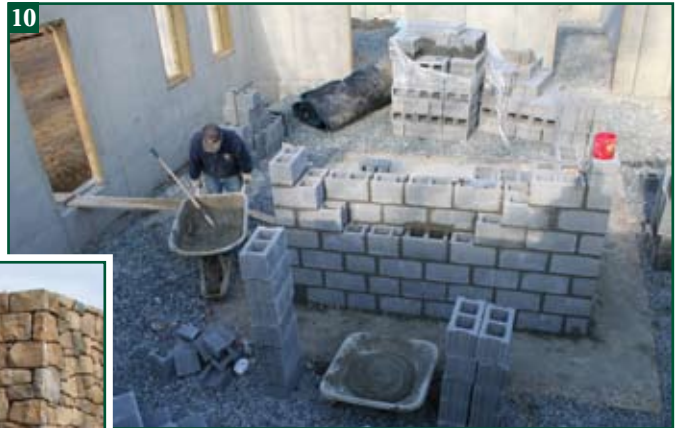
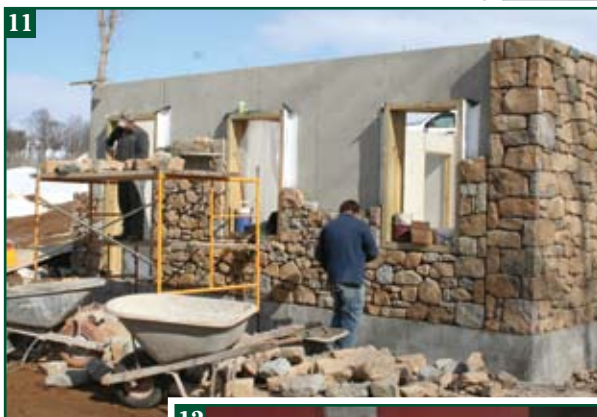
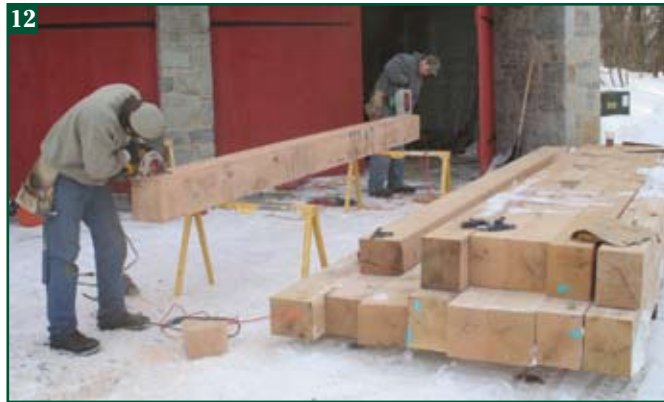
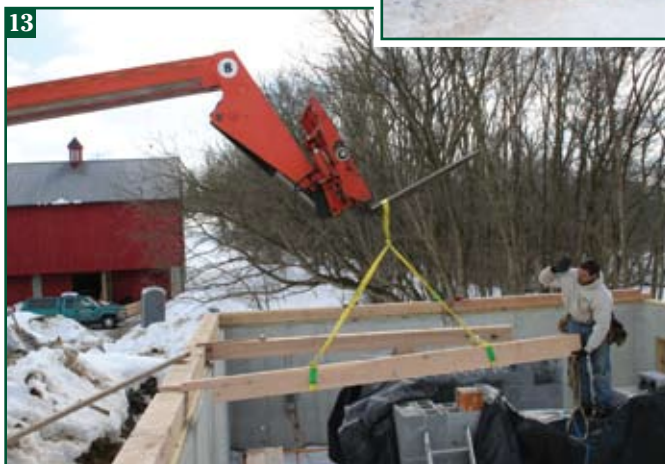
Most of the concrete walls had a built-in ledge at the base of the wall to accommodate the stone veneer. But some areas of wall had to have a ledge built into them; Sonny Weaver did that with block. **(Photo #9)** Sonny also laid up a 3-sided base for the central fireplaces **(Photo #10)**, full height of the basement, and then poured another reinforced concrete slab on top of that. The open side of the base would become a large alcove in which Tim could store firewood and also install a wood stove. Altogether, there would be three fireplaces on the upper floors, as well as a bake-oven, and the wood stove in the basement.

Back-to-back snow storms also had everyone — masons, carpenters, everyone! — digging snow just so they could continue working. Thankfully, the weather gave them a break and they could work without tents. **(Photo #11)**

The masons laid up a fake vertical joint at one end of the house so that it would appear that the new additions were built at a later era than the old house. The masons also used smaller stones in that “new” section and incorporated gray

stones from the previous barn project; another way to make that section of the foundation look slightly different from the “old” house section.

dimension as the original. Steve and Ryan Sload recreated the old timber joists using half-lap joinery. **(Photo #12)** The new “old” joists were then set in place with assistance of an all-terrain forklift — better known in the trades as a “pettibone.” **(Photo #13)**
